A lot of hot air: Report on fire extinguisher misfire on s/v Jessica Mei

Vessel: Jessica Mei, Island Packet 44, MMSI 235059182

Date of incident: Approx 1445 hrs UTC Tuesday 29th November 2022

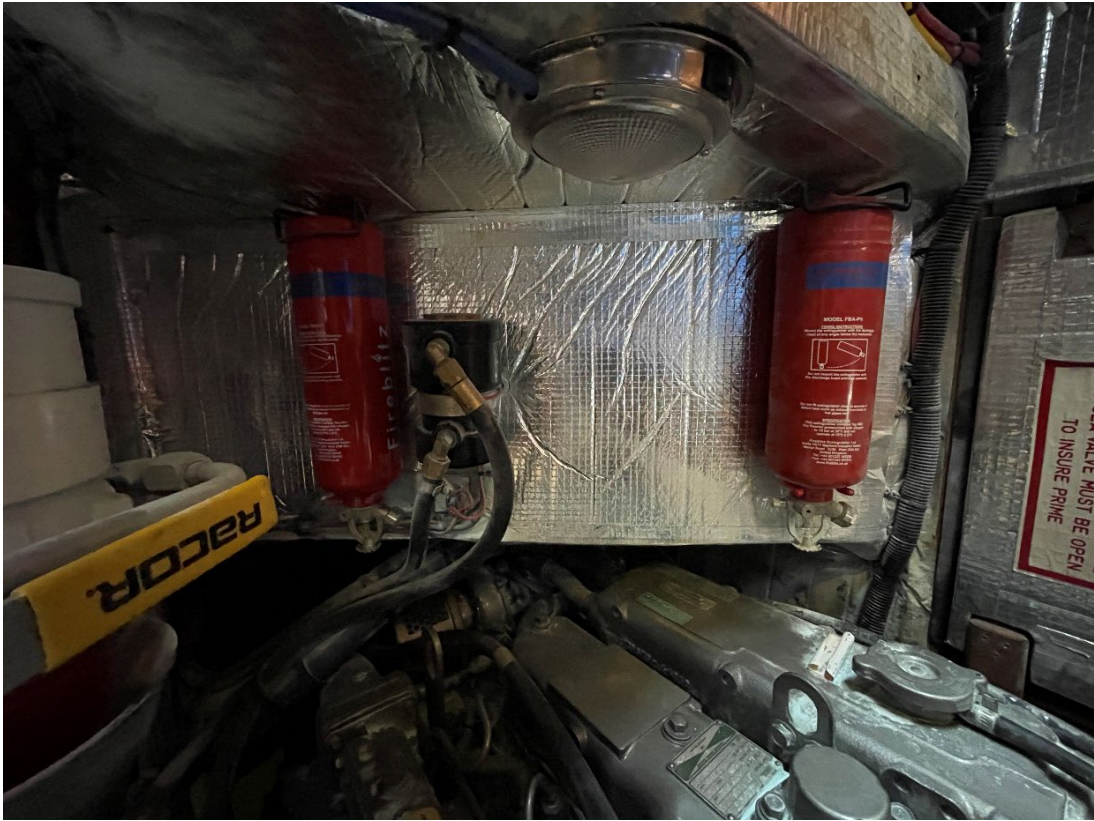
Once safely anchored, we made a cup of tea and tried to figure out what had set the fire extinguisher off. Jessica Mei is fitted with two automatic engine extinguishers in the engine bay. Only the one on the port side of the engine bay had misfired (Fig. 1). Before the engine was shut down, Jack and Bill had seen the engine's operating temperature, which had all been normal, with no alarms sounding.

Fig. 1: Only the fire extinguisher on the right of the picture had fired. This photograph was taken after the initial cleaning with the dinghy pump.

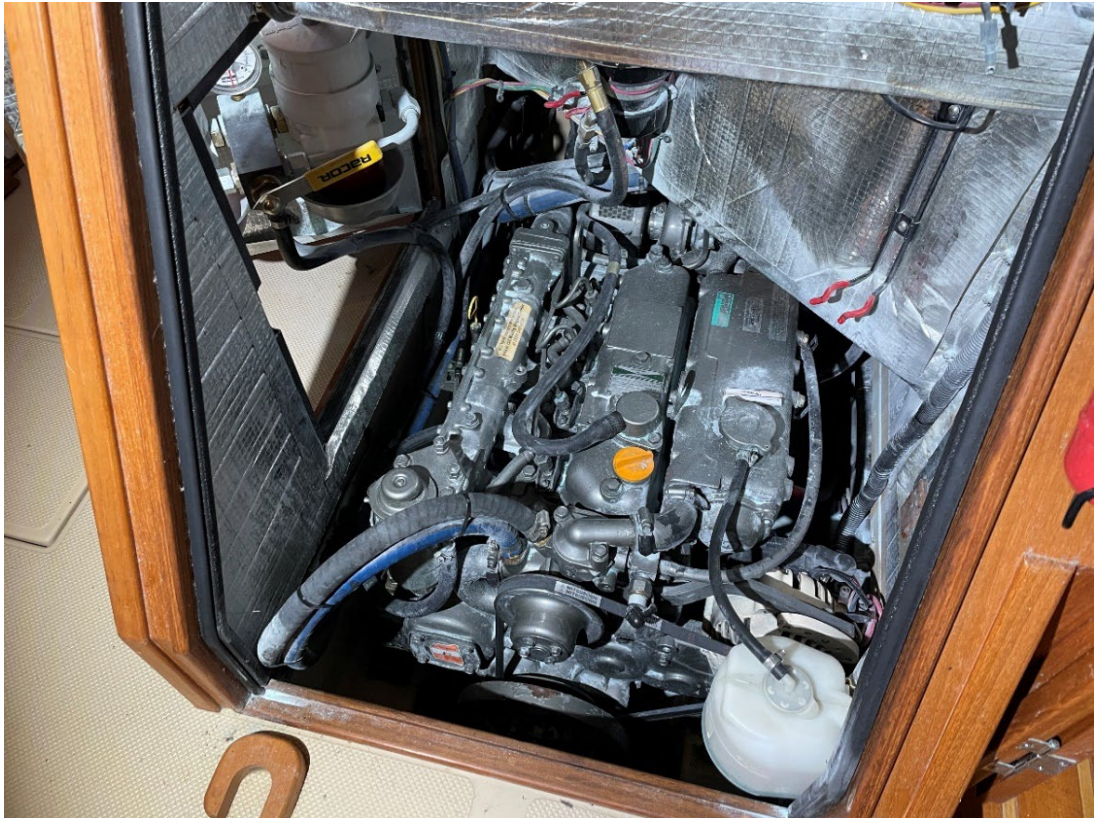
Fig. 2: The Yanmar 75hp engine after the initial clean with the dinghy pump.

With the engine as clean as possible without a vacuum (Fig. 2), we reinstalled the air filter and attempted restarting it. It took longer than usual to fire up; once going, there was loud metallic knocking from the engine that wasn't normal, so we immediately switched it off. We attempted to clean more, then tried starting the engine again. This time the engine started immediately, but the metallic ringing was still clearly heard, so we turned it off. We were concerned that permanent damage may have been done to the engine by the fire extinguisher powder and considered it should not be restarted until it had been checked over by an engineer.

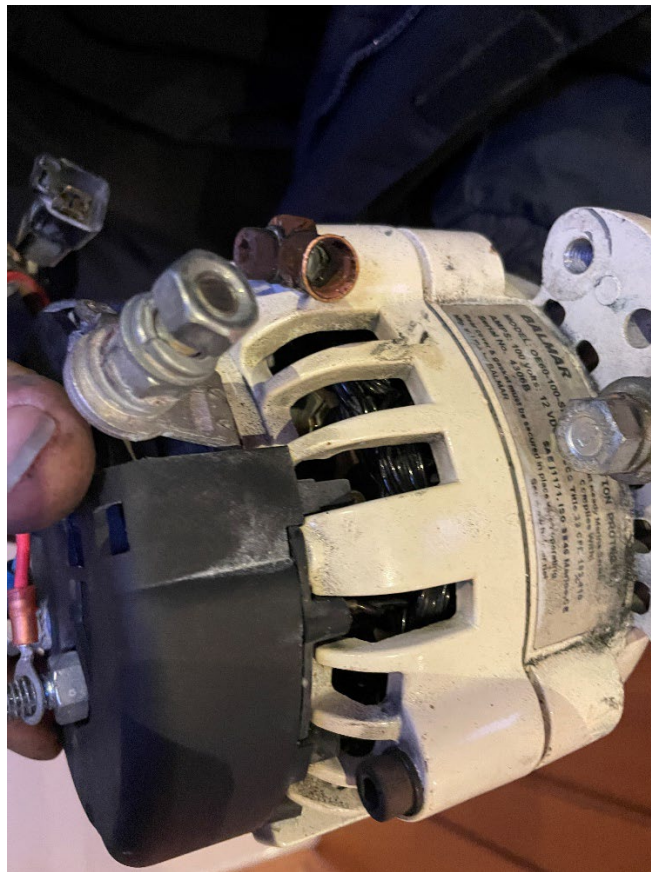
With the engine now running normally, the engineer conducted various other checks. He found that the alternator was running very hot. The temperature sensor on the alternator had become detached, and the copper wiring inside the alternator was visibly blackened. (Fig. 6). I attempted to touch the alternator, but it was too hot.

Fig. 6: The wiring inside the alternator should be a bright copper colour. The copper fitting at the top of the picture is where the temperature sensor is attached.

The electrician found that the Balmar alternator had severely overheated and reported that the only thing to do would be to install a new Balmar alternator and regulator. These were not readily available in Hamburg. Later that day, he called to confirm that he would have a replacement by Tuesday, 6th December and would be able to come and fit it on the morning of Wednesday, 7th December. As this was our only option, we agreed to this timeframe, although we would miss our weather window of easterlies for easy sailing back to the UK.

The hole where the hot air entered the engine bay was directly behind the alternator. As well as setting off the fire extinguisher, I am confident that the escaping hot air also overheated and damaged the alternator.

I can't be sure whether the temperature sensor broke due to this heat and extinguisher going off above it, or if it had broken beforehand. As many alternators do not have a temperature sensor, I do not think an overheating alternator could have set off the fire extinguisher on its own. It could have contributed to the heat in the engine bay though.

The electrician came as scheduled and replaced the alternator and regulator. Once this was fitted, I changed all the fuel filters. We filled up with water and left that afternoon.

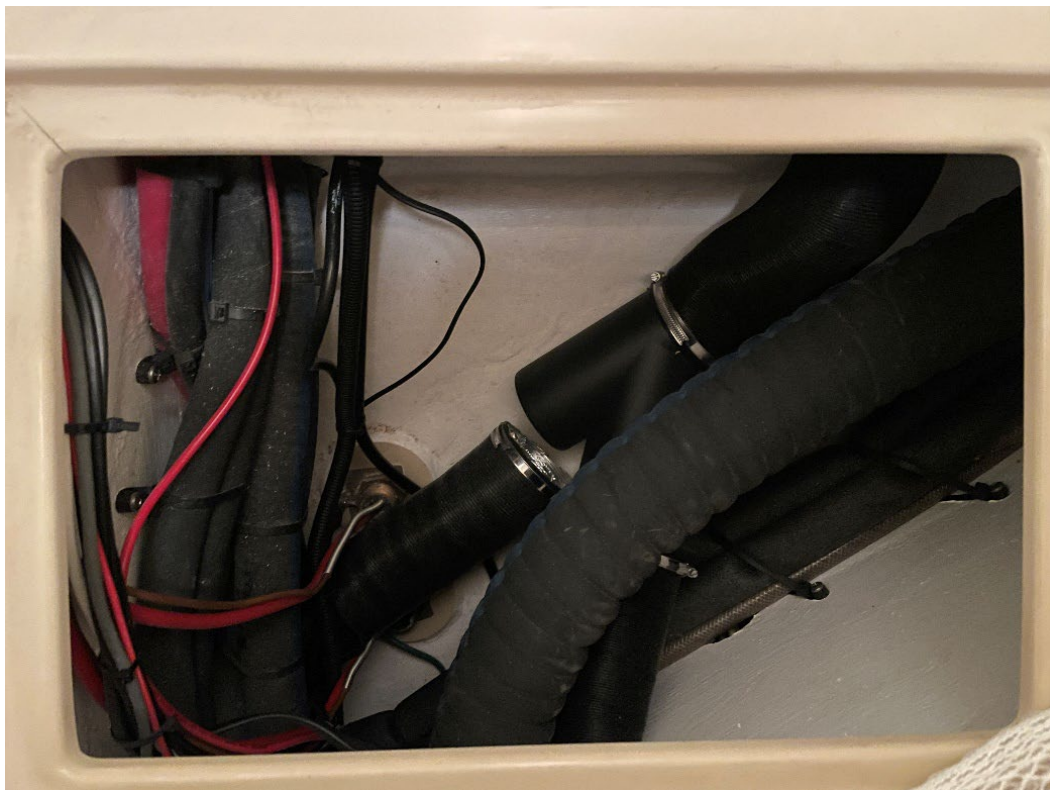
During this clean-up, they accessed a locker behind the engine bay, under the quarter berth—this locker communicated directly with the engine bay via holes for pipework for the exhaust and other plumbing. Here we discovered that the heating duct had disconnected from a Y-connection in this locker (Fig. 7 and Fig. 8). The disconnection resulted in a lot of hot air from the heater being pumped directly into the locker, escaping through the holes made for pipework into the engine bay. The holes that communicated with the engine bay were on the port side of the engine bay. Positioned directly behind the alternator and below the extinguisher that misfired.

The heater was on when we discovered this. The locker walls were very hot to touch, as well as the engine bay, even though the engine has not been running that day.

Fig. 7: The inboard quarter berth locker with the Y-connector in the heating duct. The walls of this locker were too hot to touch. The hole to the engine for pipework was to the bottom left of the picture.

Following this discovery, the ducting for the heater was reconnected and the entire run was inspected. The ducting was repaired in the starboard cockpit locker, where the heater is. This run was very short and had no support or protection. It was inevitably knocked about by fenders kept in that locker while sailing. (Fig. 9)

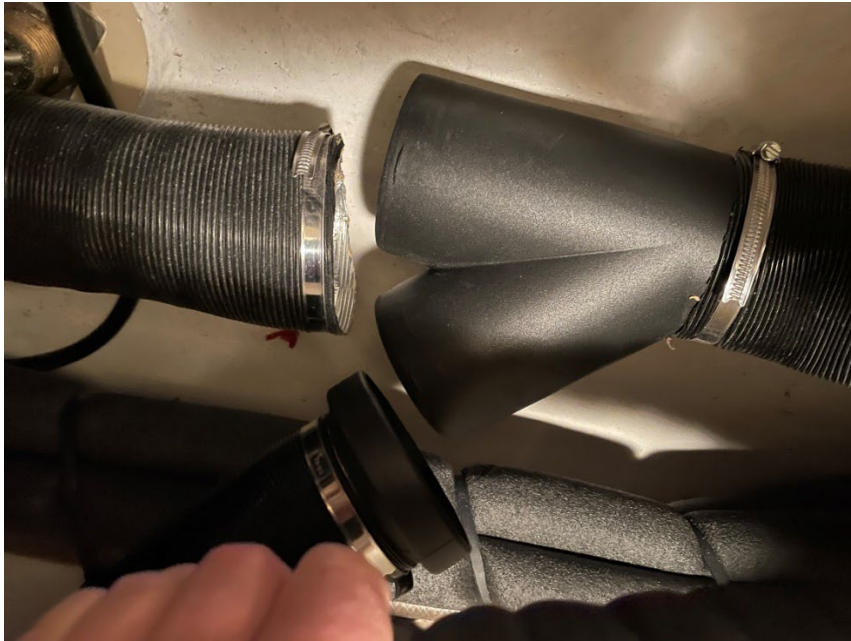
Fig. 8: Close-up of Y-connector. Both connectors had become detached as pictured. The hot air was being blown directly into the port side of the engine bay.

We were initially baffled by the fire extinguisher misfiring. Once we discovered the disconnected heater ducting in the locker, it was clear that this was the cause. The engine bay is well insulated. The locker where the disconnection had occurred had a mattress above it. Both areas had efficiently trapped the heat from the heater until 80°C was reached and the fire extinguisher fired. Therefore, the fire extinguisher did not technically misfire – although there was no fire.

The heating system had been installed relatively recently, about 18 months ago. The run from the heater through the cockpit locker to the locker under the quarter berth was very short and stretched tight. It was inevitable that this would either pull off the Y connector or break entirely. It was also inadequately installed, with no supports or protection from other items stored inside the cockpit locker – such as the fenders. The ducting in the cockpit locker was pulled around by the normal motion of sailing and caused the Y connector under the quarter berth to become disconnected from the other ducts. The disconnection probably occurred soon after the heater had been installed. There was a 3" tear in this first length of ducting in the cockpit locker, which is further evidence that this length had not been installed with sufficient protection for going to sea.

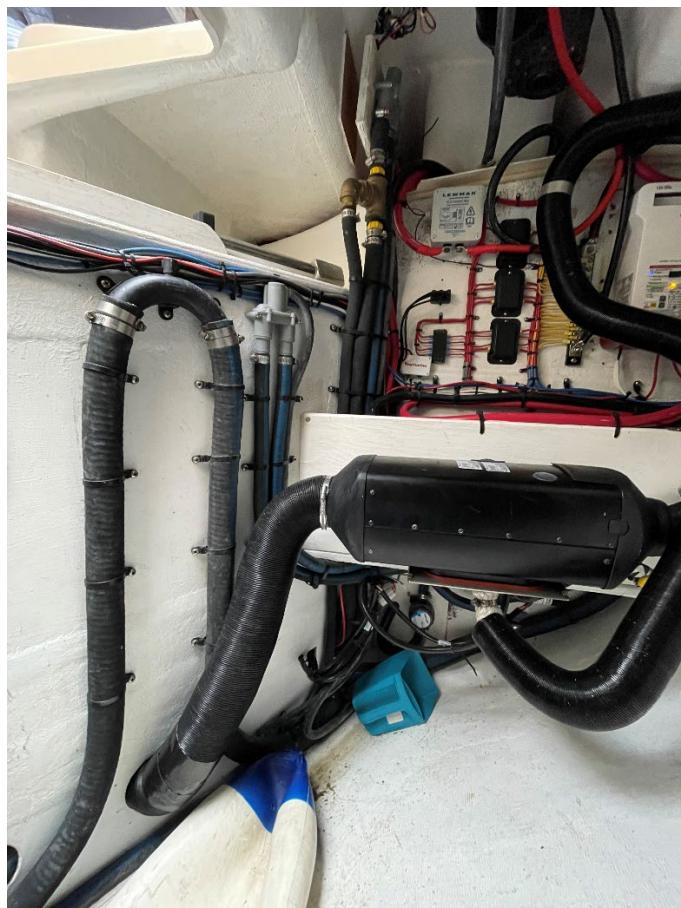
Fig. 9: The heater in the cockpit locker. Notice how securely fitted the bilge pump pipes are compared to the retro fitted heater duct. As well as being well secured to the bulkhead this section of ducting should have been of a stronger material, or had a guard made around it, to prevent if from being damaged by items stored in the locker. The tape at the bottom is our repair to a 3" tear in the duct.

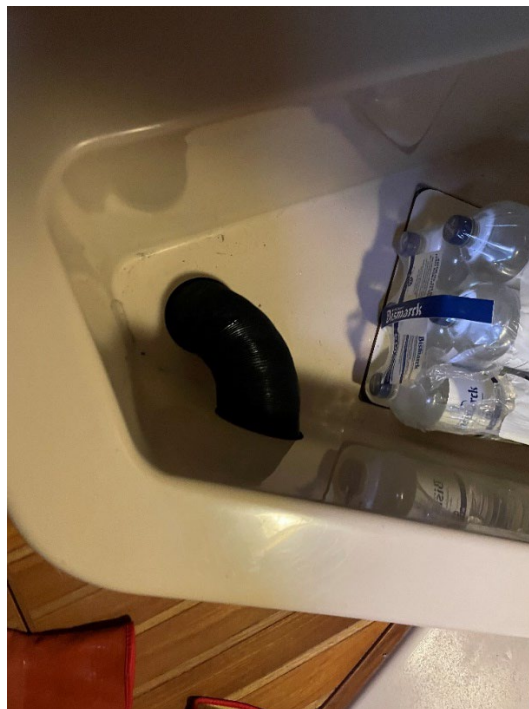
On inspection of the heating ducting throughout Jessica Mei, there were numerous locations where the ducting had been installed with little thought. In multiple locations, it compromised the locker space in a manner unsuitable for a seagoing vessel (Fig. 10). For example: the duct was left on the floor in the locker under the starboard settee (Fig. 11). This position meant it would be immediately squashed by anything put into that locker. There were also sections of the ducting that had lagging, mainly in the middle of the run. Then other sections had no lagging. There seemed to be no logic to the distribution of this lagging.

Fig. 10: The heater duct in the outboard quarter berth locker is badly exposed to being bashed around by whatever is stored there, emergency water in this instance.

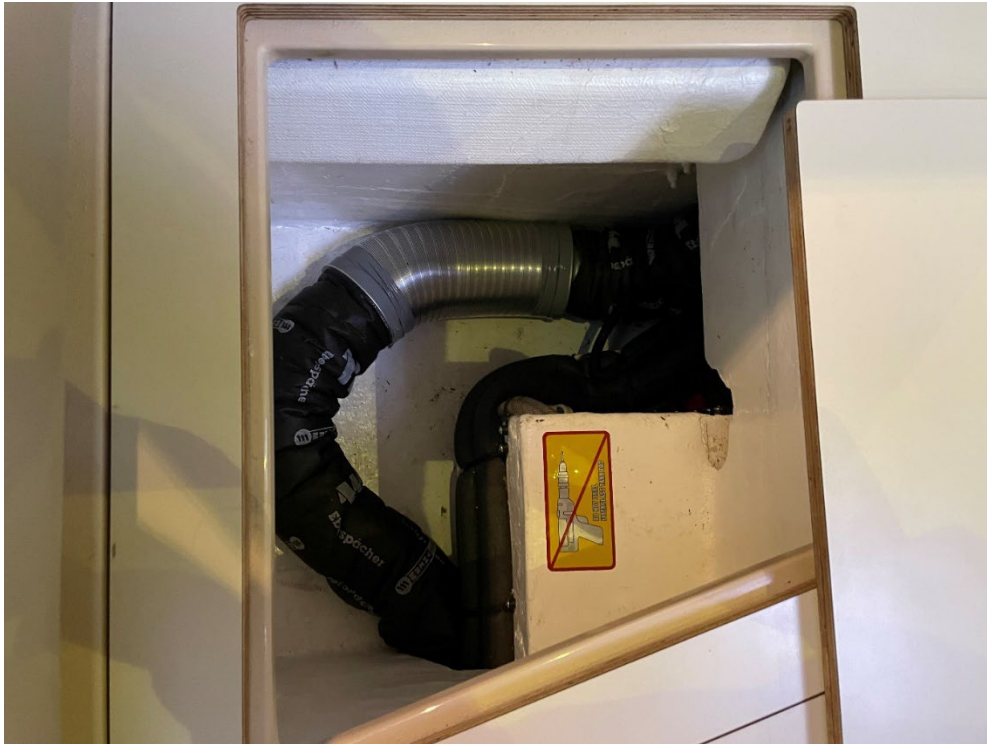
Fig. 11: The ducting installation in the locker below the starboard settee has been left lying on the floor. This position means it's impossible to use this space for storage now. It would have been much better to mount the ducting higher up on the outside locker walls, keeping the bottom clear, so this sizeable locker space could still be used without the duct getting damaged.
