A lot of hot air: Report on fire extinguisher misfire on s/v Jessica Mei

Vessel: Jessica Mei, Island Packet 44, MMSI 235059182

Date of incident: Approx 1445 hrs UTC Tuesday 29th November 2022

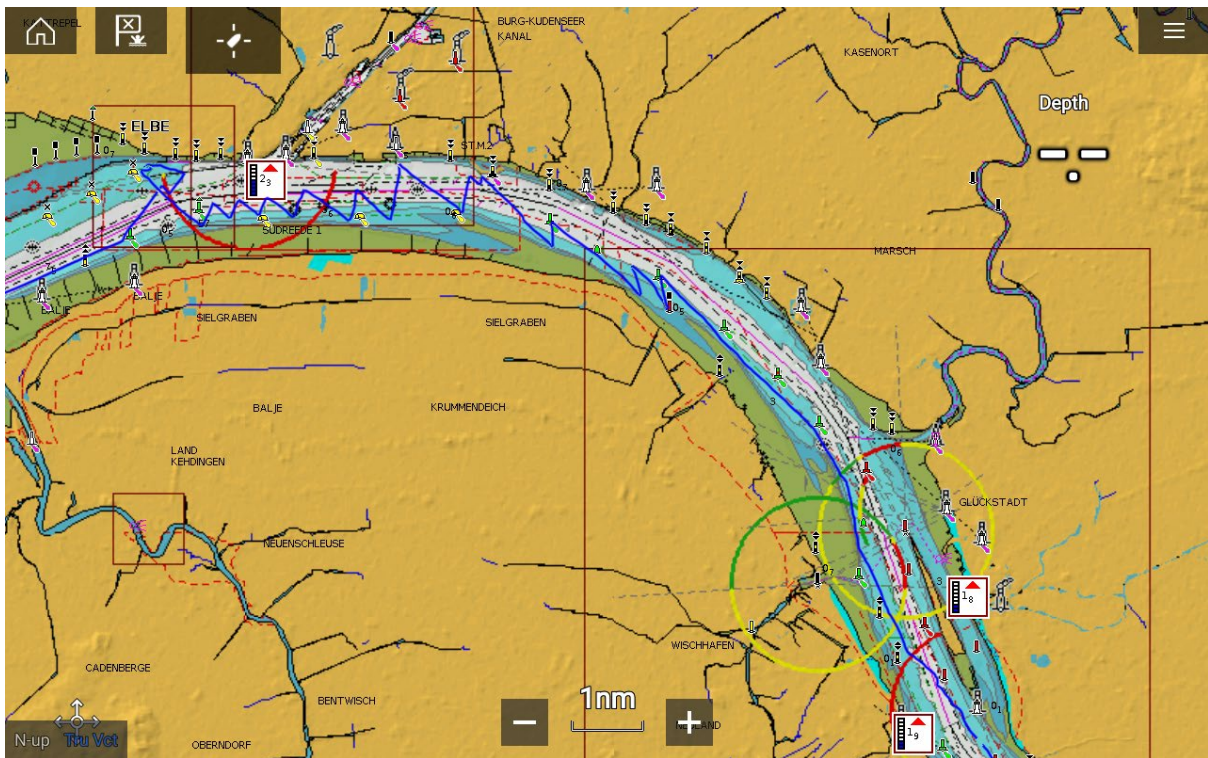
Once the anchor was up, we unfurled the headsail and started tacking up the Elbe (Fig.3). As soon as we had a longer tack we also pulled out the main (Jessica Mei has in mast furling). We cleared the bend in the river just before the tide turned as planned. From there, we could hold one tack a lot easier with the easterly wind. As the winds were light – F2-3 – it took us 10 hours to cover the 35 miles or so to the outskirts of Hamburg. We considered going into marinas as we passed them. The first was Glückstadt, but they had no boat available to tow us onto a pontoon or a 240v hook-up. The Hamburger Marina was closed for the winter. Our original destination, Hamburg City Sporthafen, was our only option. While sailing up the Elbe, the batteries read 12.1v. To try and avoid permanent damage to the domestic batteries, Jack wired the engine start battery as the domestic supply, giving us plenty of power to run instruments.

Fig. 3: Tacking up the Elbe, starting from our anchorage to the west of the entrance of the Kiel Canal

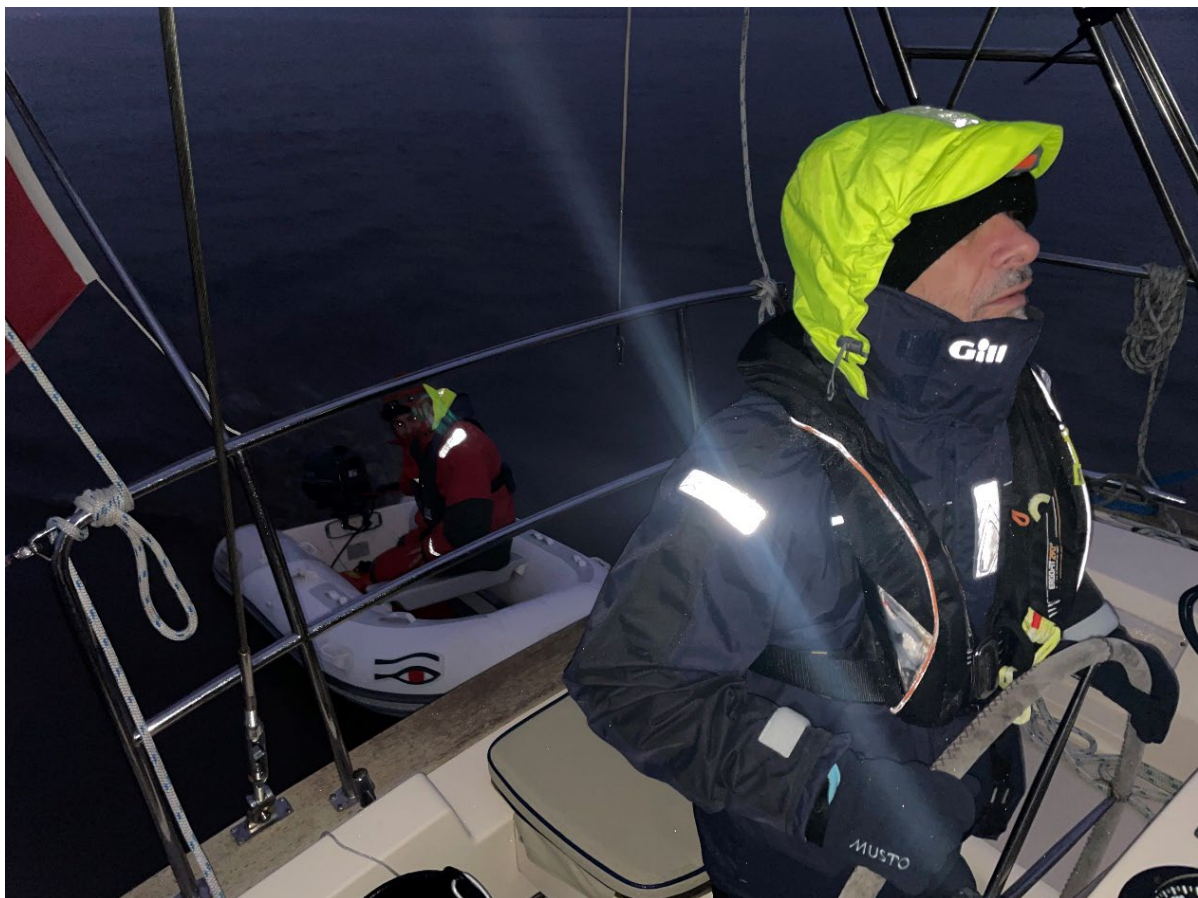
Fig. 4: Jack in the tender with the 6hp motor, Peter at the helm.

As we approached the city, the topography changed, blocking the wind on the river. We launched the tender with the 6hp petrol motor. Jack used it to push Jessica Mei at 2-3 knots STW (Fig. 4). All wind had gone now, and we entirely relied on the little 6hp motor to keep us moving. We covered another 5 NM or so in this way with the tide helping us. However, as each ship passed, the wash would make it impossible to keep pushing. Also, as we got closer to Hamburg, the Elbe has sections of tidal overfalls. It was clear that we would have little control as we went over these tidal overfalls, so we decided it was time to ask for the tow.

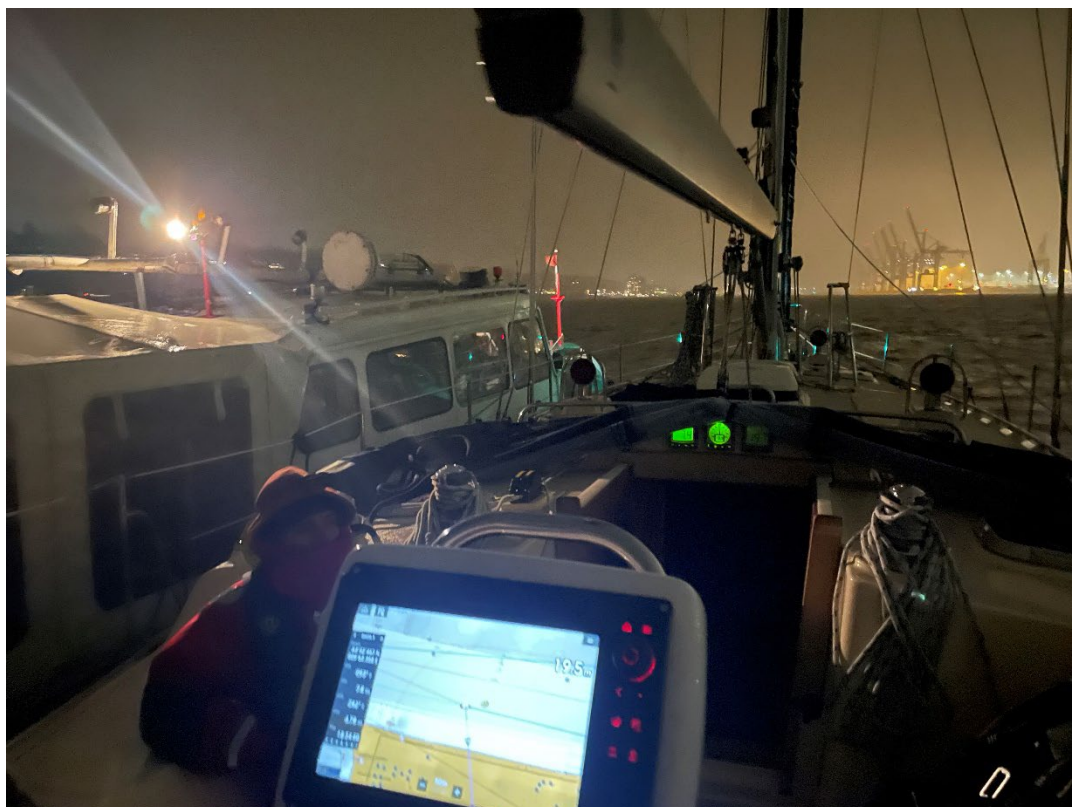
Fig. 5: The final tow into central Hamburg
